# CASE STUDY: Parallel Generation

## GenMax Application Zook Generating Station, Leola, PA

Zook Molasses Company collaborated with Granger Energy Services to build the \$5 million Zook Generating Station in Leola, Pennsylvania. The 25,000 square foot facility creates 3.2 megawatts of electricity from two CAT 3520C 1600kW generators (0.75 pitch).

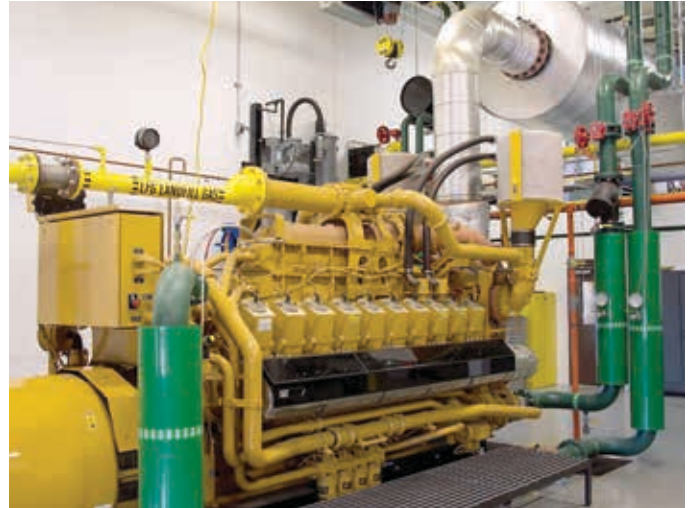
At this point the only possible explanation for the difference between neutral current measurements was the presence of harmonics and the protective relay filtering them from its calculation. After confirming this protective relay filtering behavior and measuring the harmonic content within the neutral with a true-rms meter, the cause of the inconsistency between neutral current readings was identified as harmonics. The neutral harmonic current measurement was: THD 92.5%, rms current 536A, Harmonic Content (In order of greatest to least %): 3rd, 1st, 9th, 5th, 7th, 15th, 27th. Based on the data, the engineering firm tasked with the

project reasonably assumed that there were significant 3rd harmonic generating loads in the system and that each generator would need its own neutral harmonic filter.

Using the summation of the 3 phase vector addition to determine the neutral current value, an inconsistency between the generator power meter reading and the protective relays was discovered. The results were a generator power meter reading of 534.4 amps and the protective relays neutral current calculation of 239.5 amps.
