# It Pays to Find the Right Solution

*A company's response to high harmonic currents eliminates its troubles—and increases the capabilities of the system.*

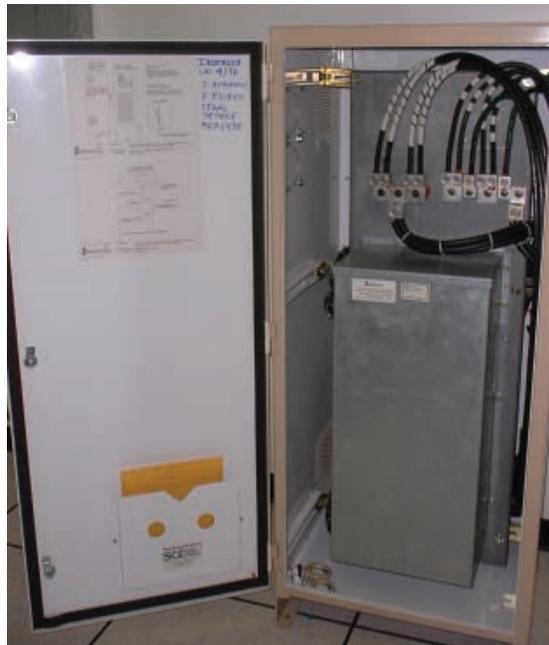
*This harmonic suppression system was the answer to one facility's problem.*

Lasher and others at Reuters considered several ways to reduce harmonic risk to the facility, including doubling neutral wires and replacing transformers with k-rated units. Ultimately, they decided to install SystemeMax on the secondary side of both transformers.

SystemeMax is a harmonic suppression system from Harmonics Limited, Monroe, Conn. Connected at the transformer, the system prevents the flow of third-harmonic current—thereby eliminating the need to beef up the distribution system to accommodate harmonic currents. If you remove harmonic currents, phase currents will also fall.

The installation was a success. After installing the harmonic suppression system on transformer No. 1, rms neutral current dropped by 71%, with the third-harmonic current decreasing by 98% to only 5A. Current THD was down by 87% in the phases and rms phase currents were reduced by 44%.
